# Town of Montgomery

## Highway Department Garage Inspection Report

300 RIVER ROAD  
WALDEN, NY 12586

March 12, 2019

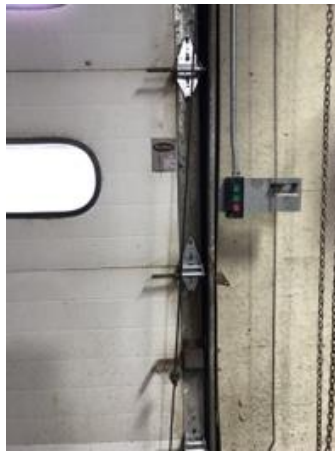
**IMAGE A-2**

- b. Exterior overhead doors were observed to be only partially functioning as intended, as damage prevented them from operating along tracks. **Reference Image A-2.**

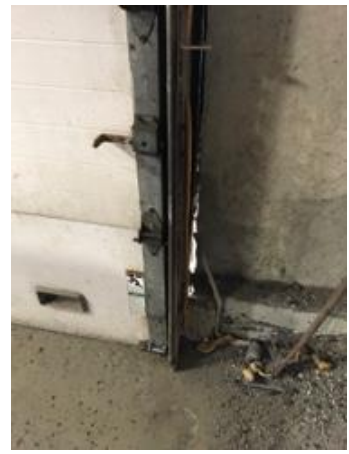
**IMAGE A-3**

- e. Roof Snow Guards are missing at employee egress and access locations.
  - f. Although the space is heated, multiple walls do not have any insulation. This is an energy code violation. **Reference Image A-3.**

- g. Interior 'liner panels' made of combustible plywood have been added to the interior side of some of the exterior walls to try to address air/water infiltration and provide general protection. This is a Code Violation. **Reference Image A-3.**

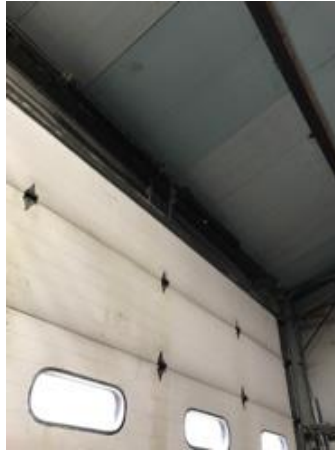
**IMAGE A-5**

- c. Some structural steel members (purlins/girts) are exposed to the exterior in areas and have deteriorated to the point where the elements can pass through. **Reference Image A-5.**

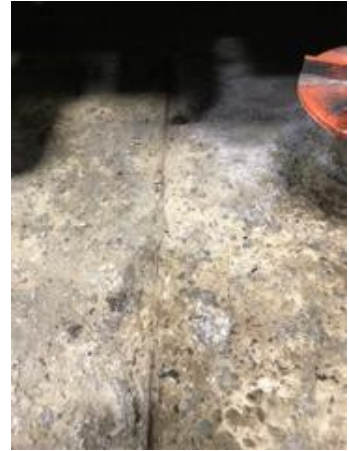
**IMAGE A-6**

- c. Excessive scaling of existing floor joint, typical throughout the original building as well as the addition. **Reference Image S-3 and A-6.**
  - d. Foundation wall adjacent to overhead door opening has severely deteriorated causing a portion of the existing foundation wall to fall apart. Existing anchor bolt is missing. **Reference Image S-5.**

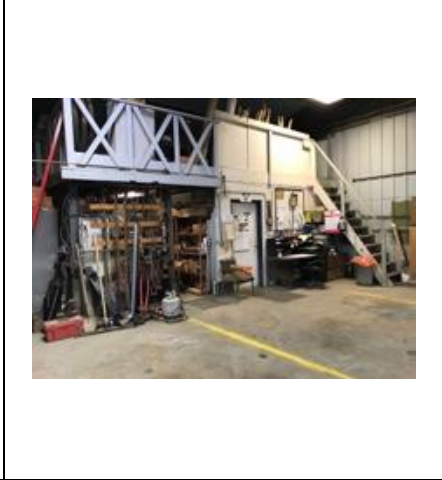
**IMAGE A-14**

- b. Stair to mezzanine does not meet current code requirements rise/run/railings/guard rail/etc. **Reference Image A-14.**
6. Mezzanine storage is for paint, aerosol cans, etc. Further analysis will need to be performed to determine quantities and hazardous storage requirements. **Reference Image A-15.**

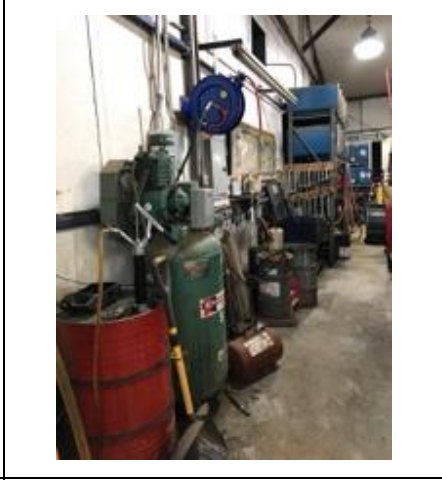
**IMAGE A-17**

9. There is currently no means to evacuate vehicle exhaust or monitor carbon monoxide. **Reference Image A-17.**
10. An existing pit was observed for changing oil. Although it was mentioned that the pit is no longer used regularly, the pit does not meet current code requirements for life safety and it is a potential hazard for those working around it. **Reference Image A-18.**

- c. There are five (5) paddle type ceiling fans in the garage to circulate air, although there is no source of outside air for ventilation, no mechanical exhaust, and no visible form of CO detection or removal. We would recommend adding OA for ventilation and exhaust to meet minimum code requirements along with a CO monitoring and alarm system.

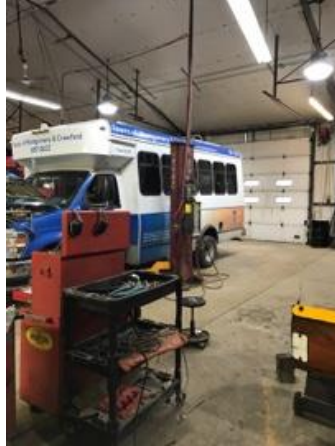
**IMAGE A-20**

11. One permanent lift was observed (12,000 lbs.). Moveable lifts are utilized for most the bays, when needed.
12. Concrete slabs have been repaired multiple times, due to damage from salt. **Reference Image A-20.**

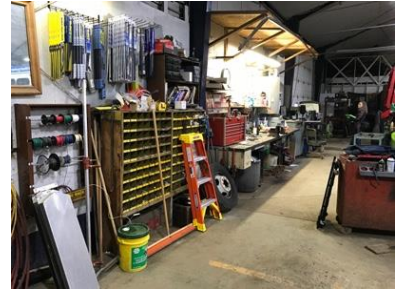
**IMAGE A-21**

1. Envelope (Roof/ Exterior Walls):
  - a. Water infiltration and damage observed at roof and walls at multiple locations on all sides of the building. To protect the mechanic's workshop area, an 'interior roof' was constructed to protect against water coming in through main roof/wall envelope. **Reference Image A-21.**

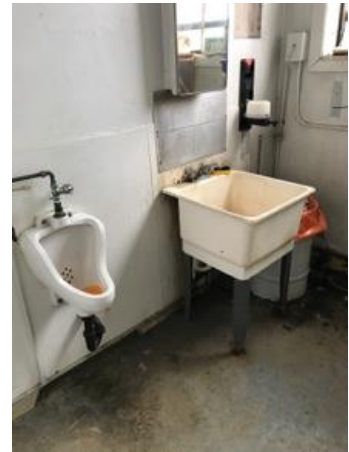
**IMAGE A-24**

- b. Restrooms are not fully functioning, do not meet accessibility requirements, and are in significant disrepair. **Reference Image A-24.**
  - c. The temporary restroom trailer at the exterior are not a sustainable solution as they do not meet the requirements associate with a permanent structure.

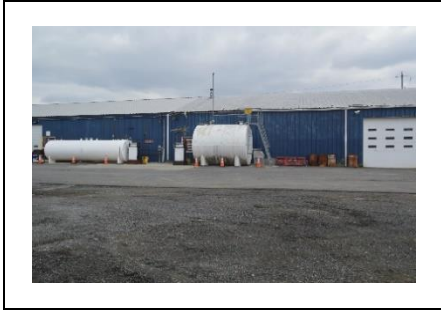
**IMAGE S-11**

- h. Damaged door jamb at an overhead door along the south elevation. **Reference Image S-10.**
  - i. Missing sections of rain gutters along the north elevation contributing to structure deterioration. **Reference Image S-11.**

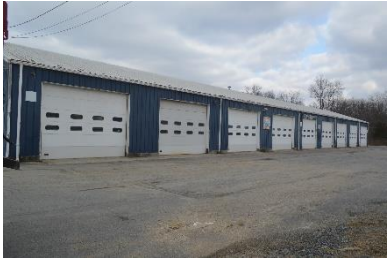
**IMAGE S-12**

- j. Downspouts outlet to grade immediately adjacent to the foundation wall along the south elevation promoting deterioration. **Reference Images S-12 and S-14.**

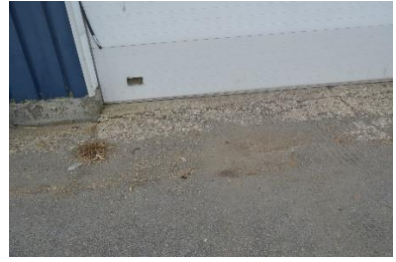
**IMAGE S-13**

- k. Spalling slab on grade at the overhead door entrance. **Reference Image S-13.**
- 2. Bus Storage:
  - a. The existing structure appears to be in generally good condition. **Reference Image S-15.**

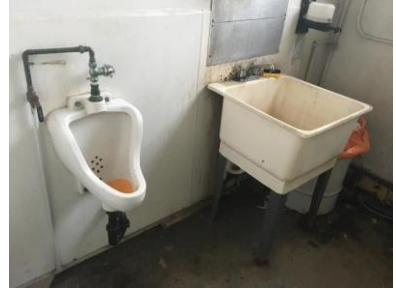
**IMAGE P-1**

3. Existing toilet room fixtures are old and in poor condition. Replacement is required. **Reference Image P-1.**
4. There are multiple hose bib drops in the garage bays for washing down maintenance vehicles.

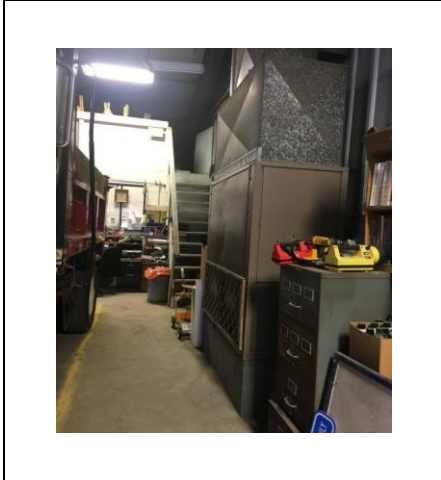
**IMAGE M-1**

1. Garage HVAC Systems:
  - a. There are no air conditioning systems serving any parts of the garage.
  - b. Heating is accomplished using two oil-fired floor-mounted furnaces (**Reference Image M-1**); one at the southern-most wall serving one half of the south portion of the building, and a second on the wall demising the two sections and serving the remaining half of the south section and the entire northern portion of the building.

- ii. Each furnace has a capacity of 340,000 BTU/hr output which equates to ~70 BTU/SF. Although normally more than enough for a building of this type (30-35 would be expected) it is reported that there are times when the temperatures inside are quite low, which is consistent with the many leaks and inadequate insulation. It has been reported that the units struggle to keep up and often run full out continuously resulting in close to 600 gallons of diesel fuel consumption per week.

- iii. Since natural gas is available at the site, should a renovation be undertaken, it is recommended to remove the oil-fired units and install a series of gas-fired unit heaters or radiant tube heaters (or possibly some combination thereof). This will likely require a replacement and upgrade of the existing gas service.

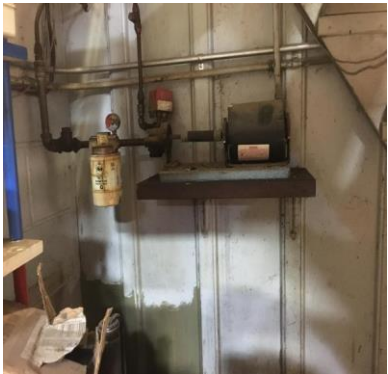
**IMAGE M-2**

- i. Each unit burns diesel oil supplied from the facilities diesel storage tank behind the building. There is a small oil transfer pump (**Reference Image M-2**) and each unit has a small “day tank” mounted high on the wall. There is central supply duct off the south unit that runs down the center of the south bay. The north unit has no duct distribution other than the open-ended discharge off the top of the unit.

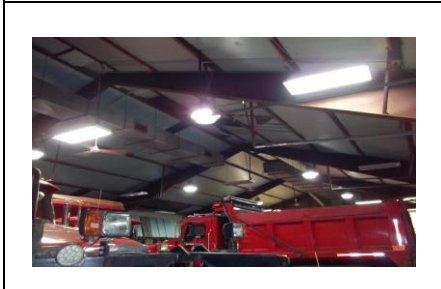
**IMAGE E-2**

6. There is no fire alarm system serving this garage. Carbon monoxide detection/alarm will be required for fossil fuel burning equipment.
7. The existing lighting consists of a variety of types to include metal halide low-bays, 6 lamp T-5 surface mount fluorescent and 8-foot long, 4 lamp, T8 strip lights. Light levels in most areas appear to be adequate, however it is recommended to upgrade all lighting to energy efficient LED type. Exterior lighting consists of building mounted HID lighting fixtures. (**Reference Image E-2**).

8. Exterior lighting consists of building mounted HID lighting fixtures. It is recommended to also upgrade these lights to energy efficient LED type.
